# **EFFECT OF AXIAL LOAD ON THE SHEAR STRENGTH OF REINFORCED CONCRETE BEAMS**

By  
M. J. BARON  
and  
C. P. SIESS

Part 2  
FINAL REPORT  
to  
THE OHIO RIVER DIVISION LABORATORIES  
CORPS OF ENGINEERS, U. S. ARMY  
Contract DA-017-CIVENG-56-6

June, 1956  
UNIVERSITY OF ILLINOIS  
URBANA, ILLINOIS

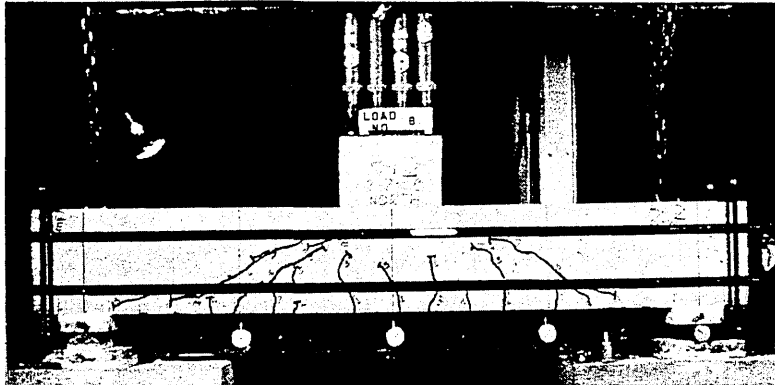
(a)  $P = 22.0$  kips

(b)  $P = 29.6$  kips

(c)  $P_u = 33.7$  kips (after failure)

FIG. 10 CRACK DEVELOPMENT FOR SHEAR-COMPRESSION FAILURE. BEAM B-12

(a) Shear-Compression Failures. Figure 10 shows the crack development for a typical shear failure. At a load of 22.0 kips the cracks were primarily flexural. Fig. 10(b) shows that at the cracking load of 29.6 kips very extensive diagonal cracking had occurred but the beam was still capable of carrying increased load. The beam is shown after failure in Fig. 10(c). All of the beams which failed in shear-compression behaved very much like Beam B-12 in Fig. 10. The following observations may be made as being characteristic of the shear-compression failures:

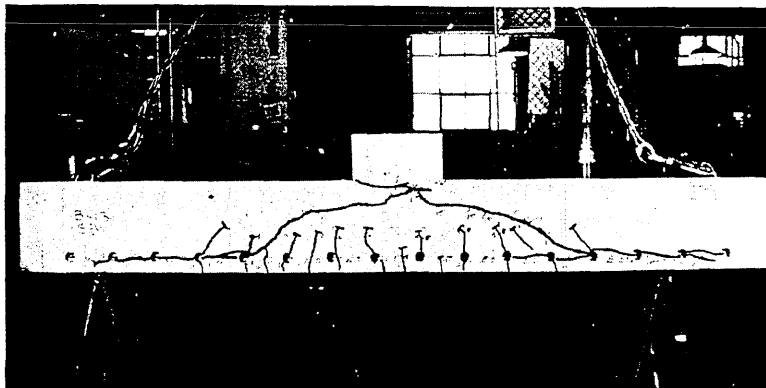
(a) Beam A-13 without axial load.  $P_u = 21.1$  kips.

(b) Beam B-13 with axial load.  $P_u = 27.8$  kips.

FIG. 14 EFFECT OF AXIAL LOAD ON MODE OF FAILURE

(2) Final failure occurred by destruction of the compression zone above the diagonal tension crack, and by splitting along the steel from the point where the crack started to the support. In four of the beams, the destruction of the compression zone was similar to that for the shear-compression failures. For the others, there was no evidence of crushing or shearing off. For beams A-3, A-13, and A-14, the compression zone was very slender as can be seen for beam A-14 in Fig. 11(c), and A-13 in Fig. 14(a). It appeared as

though the compression zone buckled. For the beams A-15, B-14, and B-15, the compression zone was not slender, and didn't buckle, but broke under the stub very much like beam B-13 shown in Fig. 14(b). For the last three beams at least it did not appear that the destruction of the compression zone was caused by excessive compressive stresses.

In all cases a horizontal crack developed during failure along the steel from the point where the diagonal tension crack started to the support. It was impossible to determine whether this crack developed before or after the destruction of the compression zone. In the discussion of the shear-compression failures it was noted that there was much cracking along the steel after diagonal tension cracking but before destruction of the compression zone. It was noted also that the steel stress was almost constant over the whole span after diagonal tension cracking. These observations indicate that the steel can be split from the concrete above it before the destruction of the compression zone, and could therefore trigger the failure. For the three beams which failed like beam B-13 in Fig. 14(b) this appeared to be what happened.

In general, diagonal tension cracks began farther from the support and did not rise as high for beams with axial load as for those without. This is shown in Figs. 13 and 14. Examination of Table 3 shows that the diagonal tension cracks did not start farther from the support in every case for the beams with axial load; however, the depth of the compression zone was greater in every case.
